Sound Insulation Test Report

Report number: 2024-269

ISO 15186-1 Acoustics — Measurement of sound insulation in buildings and of building elements using sound intensity — Part 1: Laboratory measurements

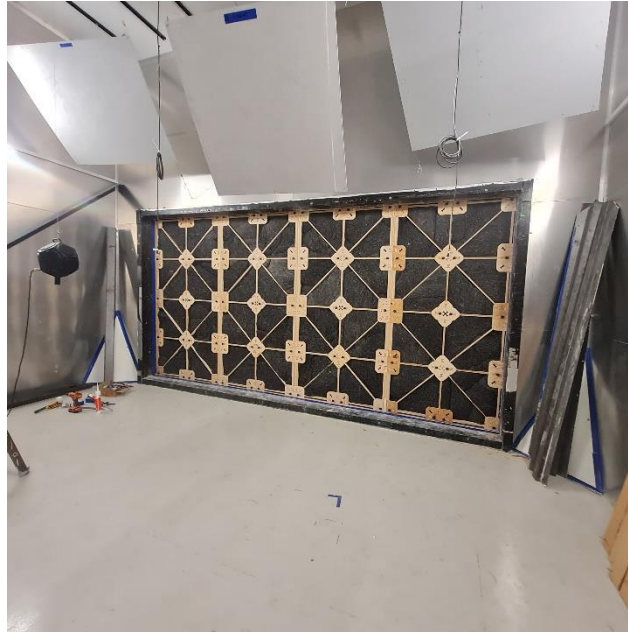
Figure 3 - Sample construction

Sample Mounting:	<p>The perimeter of the sample was sealed and flashed to control any flanking leakage. Construction of the wall system is shown in Appendix: 2, Figure 3, Figure 4</p>
Measurement Method:	<p>Generation of sound field: The test signal used was random pink noise, generated by an Apollo six channel analyser system. The signal was fed through a mixer then amplifier to two omnidirectional speakers, placed in opposite corners of the source room, to excite the sound field in the room.</p> <p>Receipt of Signal: The direct sound intensity method was used in accordance with ISO 15186-1 Acoustics — Measurement of sound insulation in buildings and of building elements using sound intensity — Part 1: Laboratory measurements. The test sample was measured using the scanning procedure in a horizontal and vertical pattern.</p> <div style="text-align: center;">

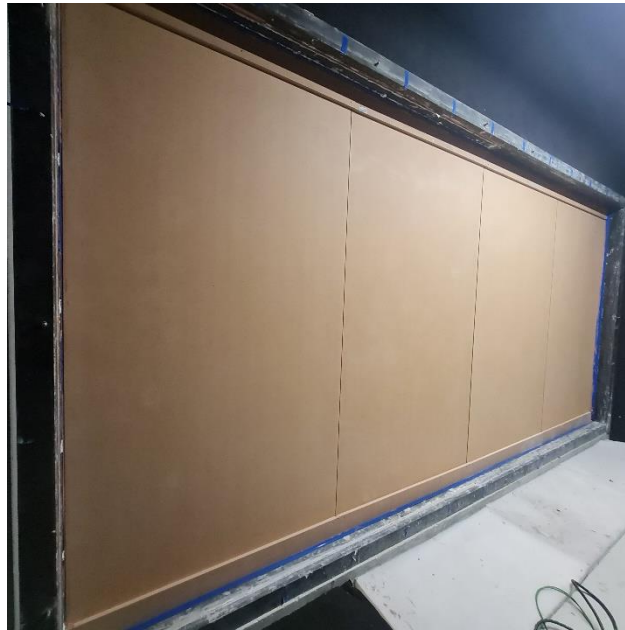
Figure 4 - Sample construction
